(Final Report, Revised October 16, 2018)  
**Condition Assessment  
&  
Reserve Fund Plan Update  
2018**

# *Lakewood Hills*

Springfield, Virginia

RE: **CONDITION ASSESSMENT AND RESERVE FUND PLAN UPDATE 2018**  
**Lakewood Hills #1 Community Association**  
(Final Report, Revised October 16, 2018)  
Springfield, Virginia  
Project No. 8439

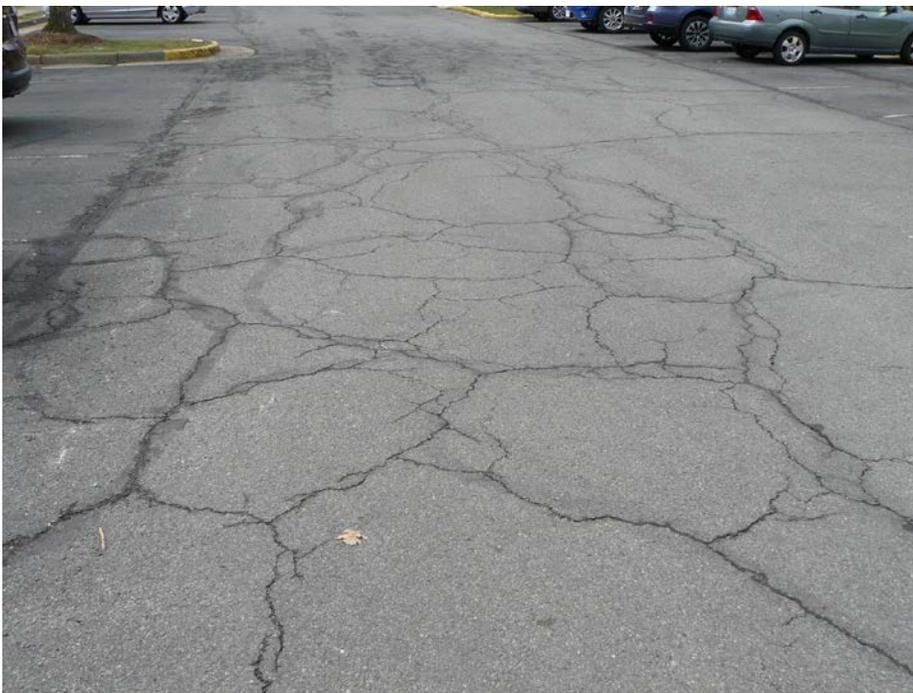
**PHOTO #1**

The asphalt driveways and parking bays are in overall poor condition. A significant amount of deflection was observed, requiring near-term restoration.

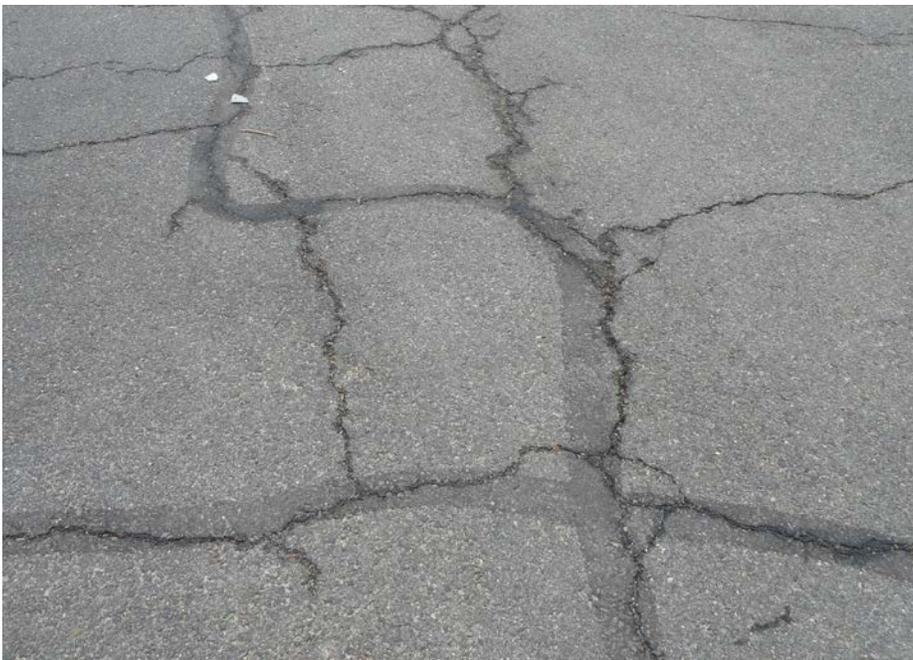
**PHOTO #2**

Some longitudinal and transverse crack filling has been accomplished in past pavement maintenance cycles. Pavement maintenance should include seal coating.

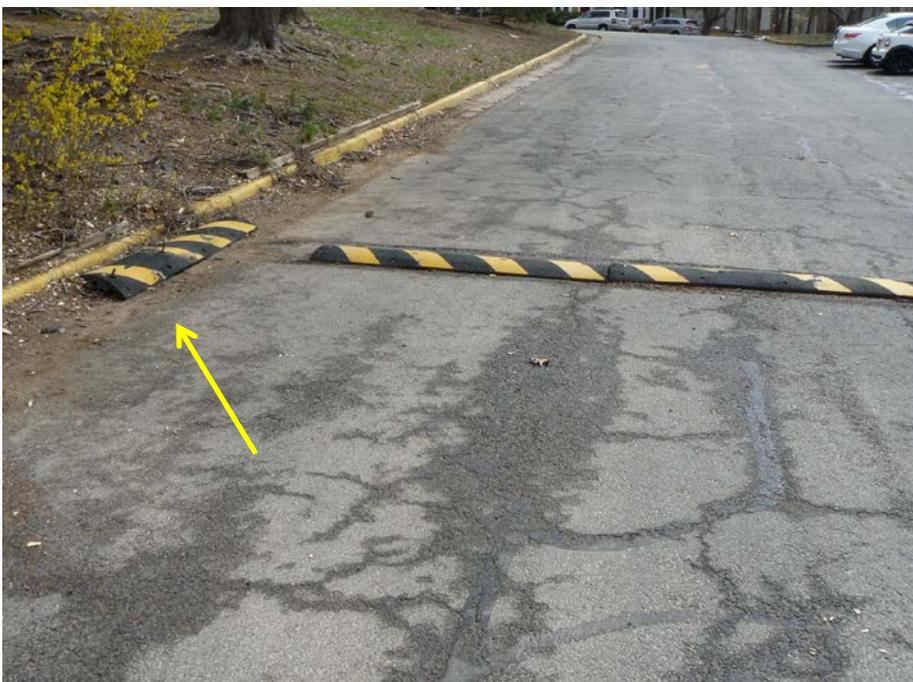
**PHOTO #3**

Rubber speed humps were installed on some of the streets. The installation has failed here. We have provided for replacement humps in the asphalt restoration project. Replacement of the deteriorated concrete humps should also be accomplished.

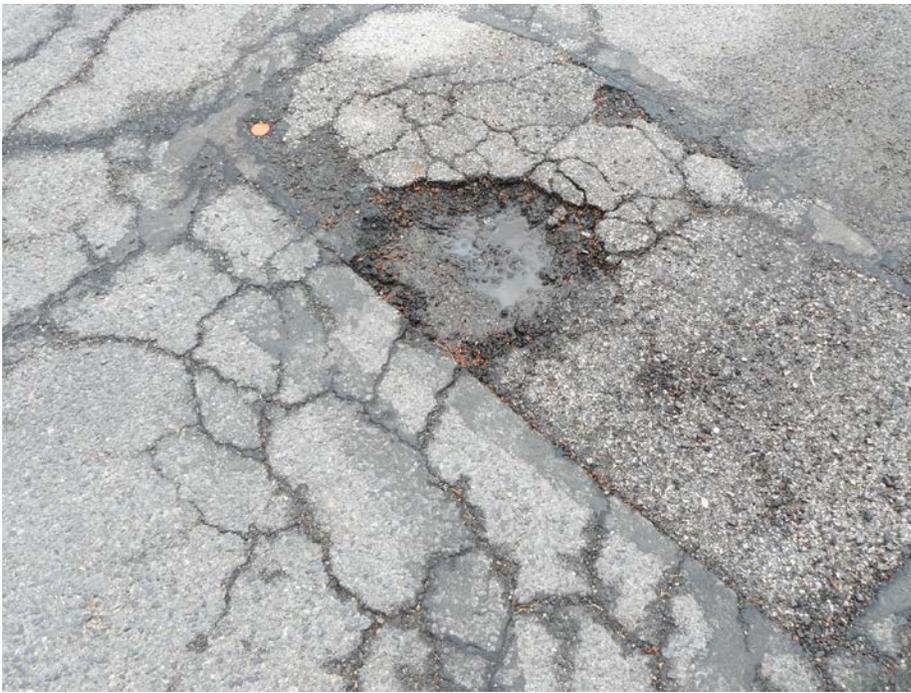
**PHOTO #4**  
Major deflection such as this requires full-depth repairs prior to restoration, to prevent the problem areas from re-occurring a year or two after full restoration has been completed.

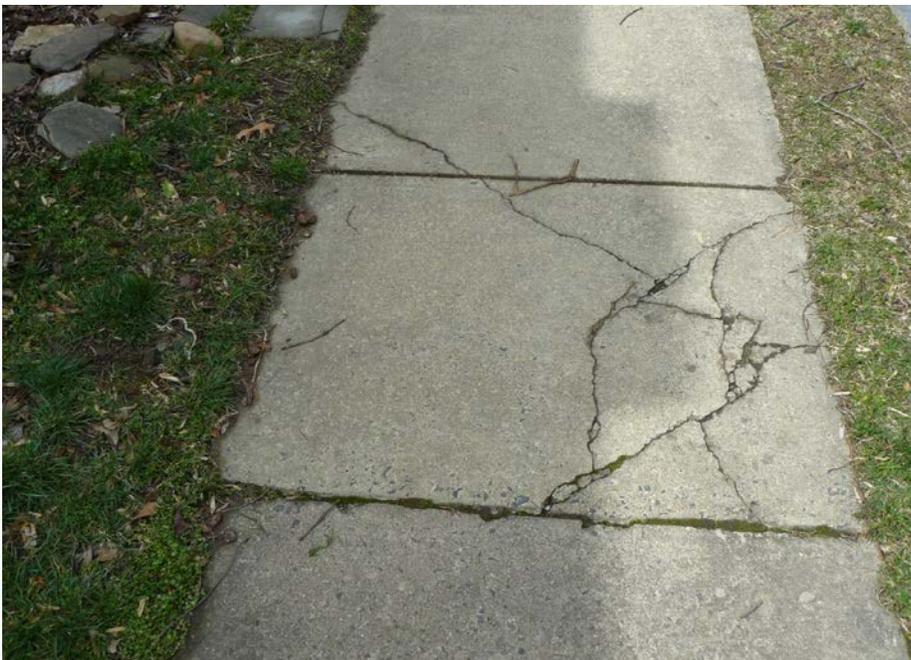
**PHOTO #5**  
Some sections of concrete sidewalk panels are cracked, requiring eventual replacement.

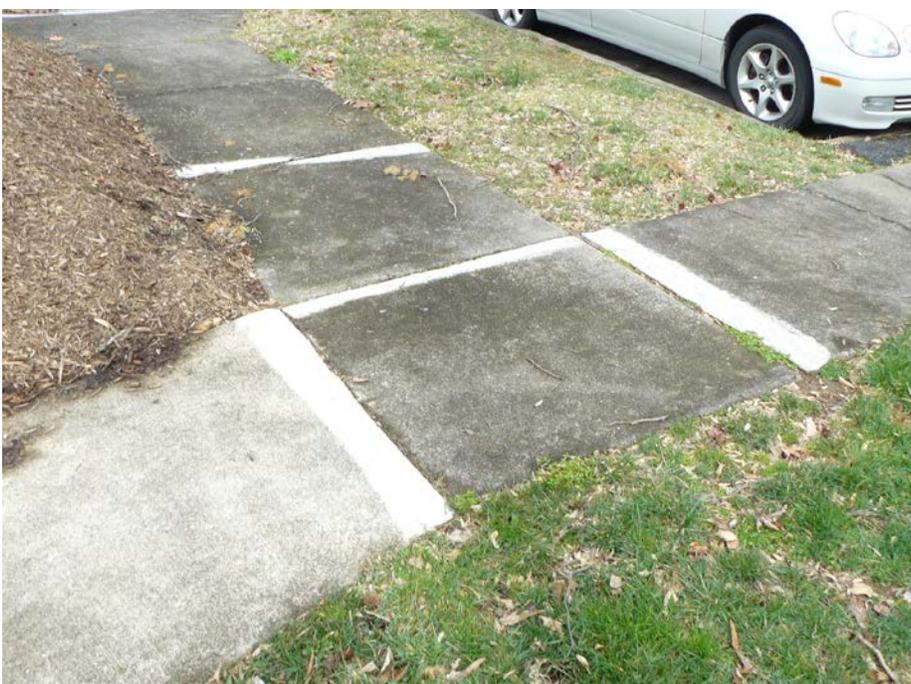
**PHOTO #6**  
Most of the sidewalk panels, which had height differentials were saw-cut to prevent tripping hazards.

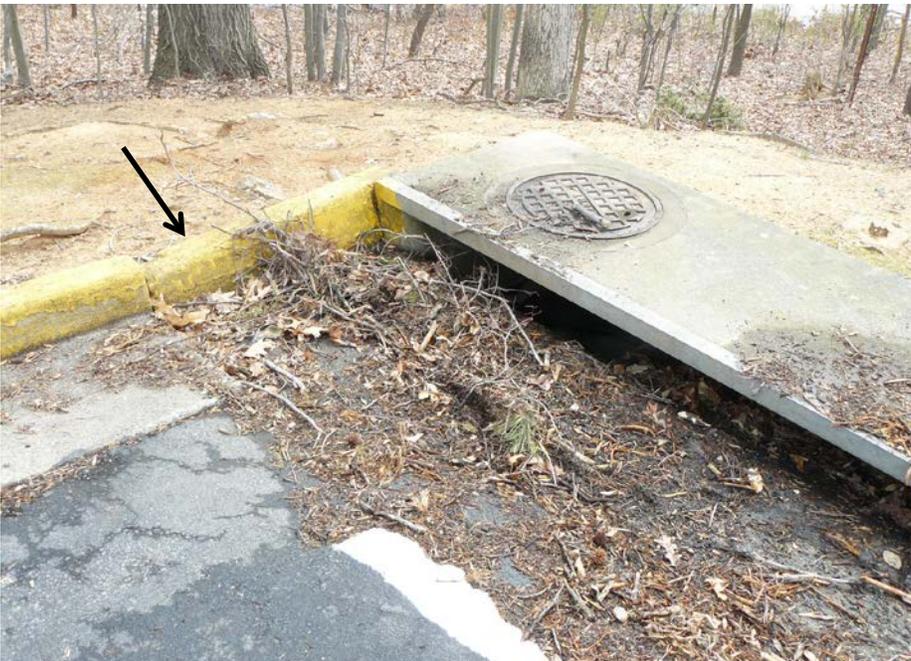
**PHOTO #7**  
Concrete curb and gutters are in generally continuing good condition. However, some sections, such as this settlement at the storm drain should be repaired.

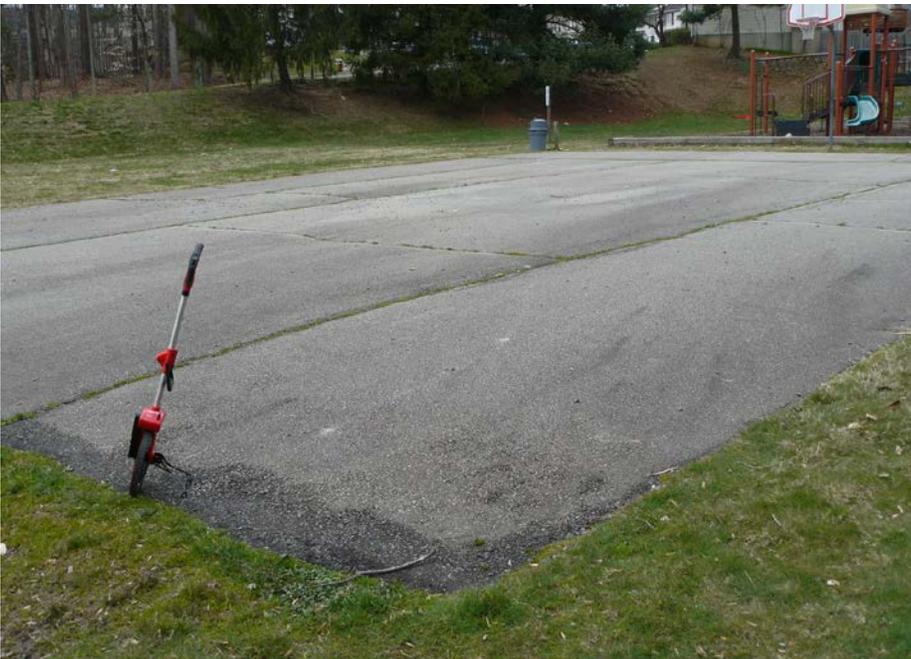
**PHOTO #8**  
The multi-purpose court has significant cracking with vegetation. These cracks can be a potential tripping hazard. The court should be restored near-term.

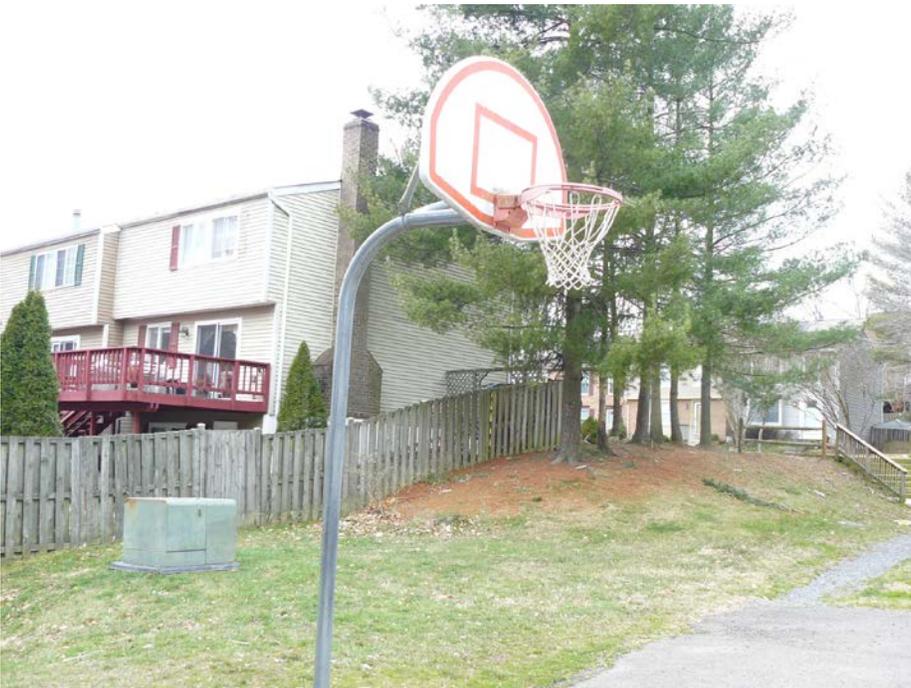
**PHOTO #9**  
The basketball goals are in fair to generally continuing good condition.

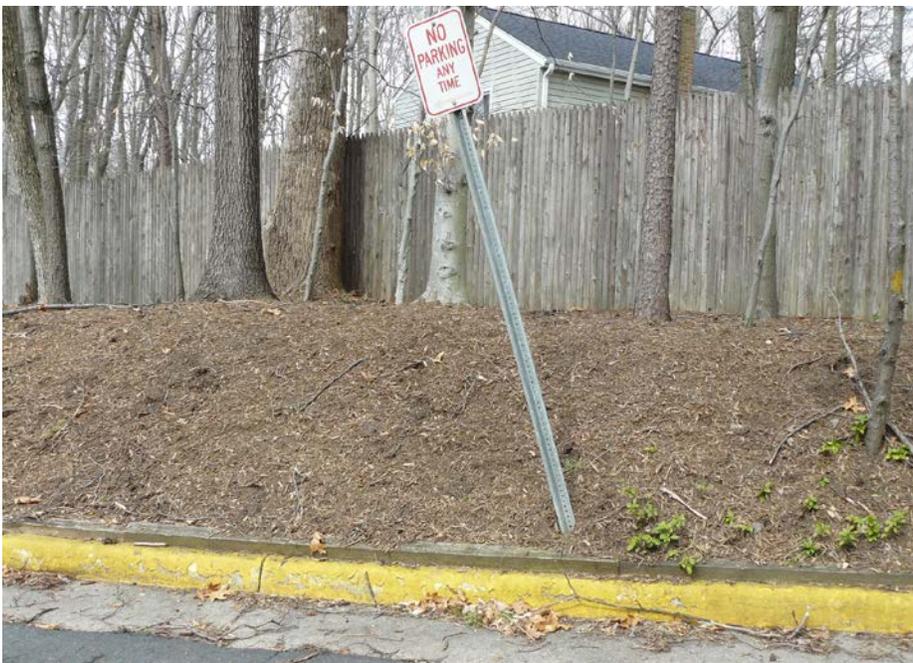
**PHOTO #10**  
The street signage ranges from poor to fair condition. Several posts are out of plumb.

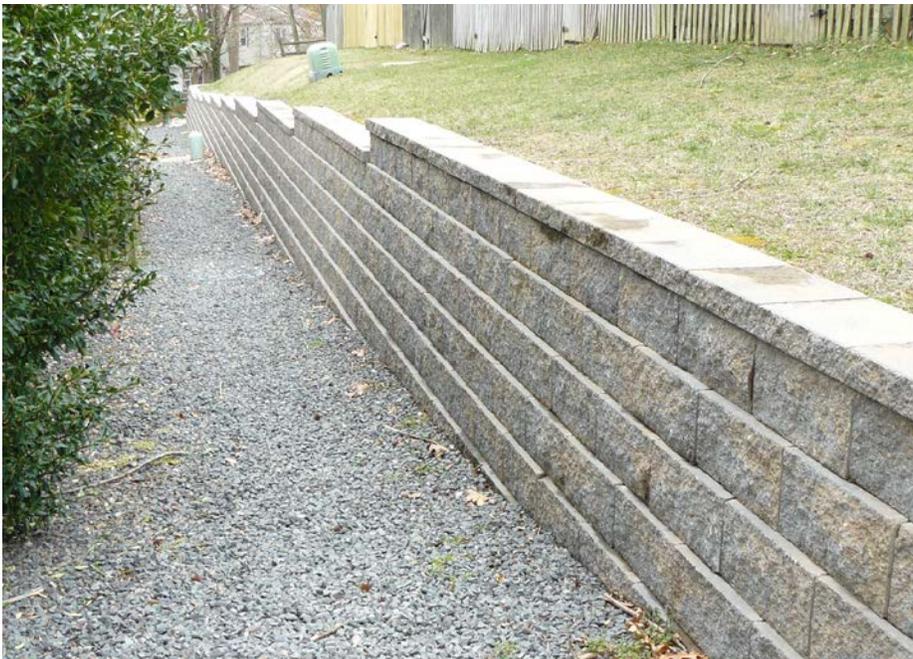
**PHOTO #11**  
Most wood retaining walls were replaced with modular block walls in 2014. The walls appear to be in continuing good condition and a major improvement over the timber walls. However, no drainage provisions were observed. Walls of this height should have railings for safety.

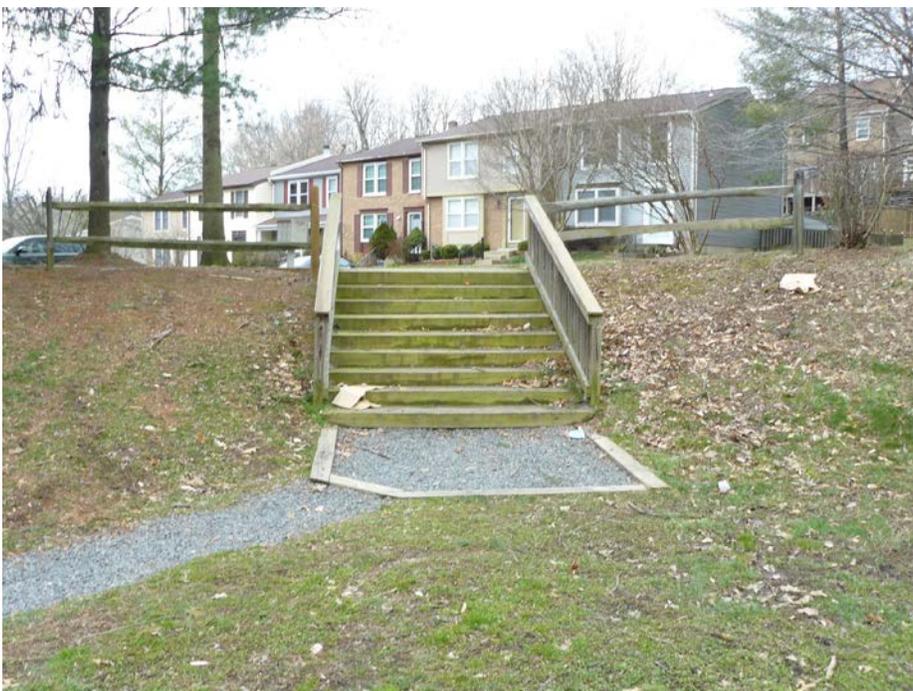
**PHOTO #12**  
The wood steps and handrailings at the multi-purpose court are in fair to continuing good condition.

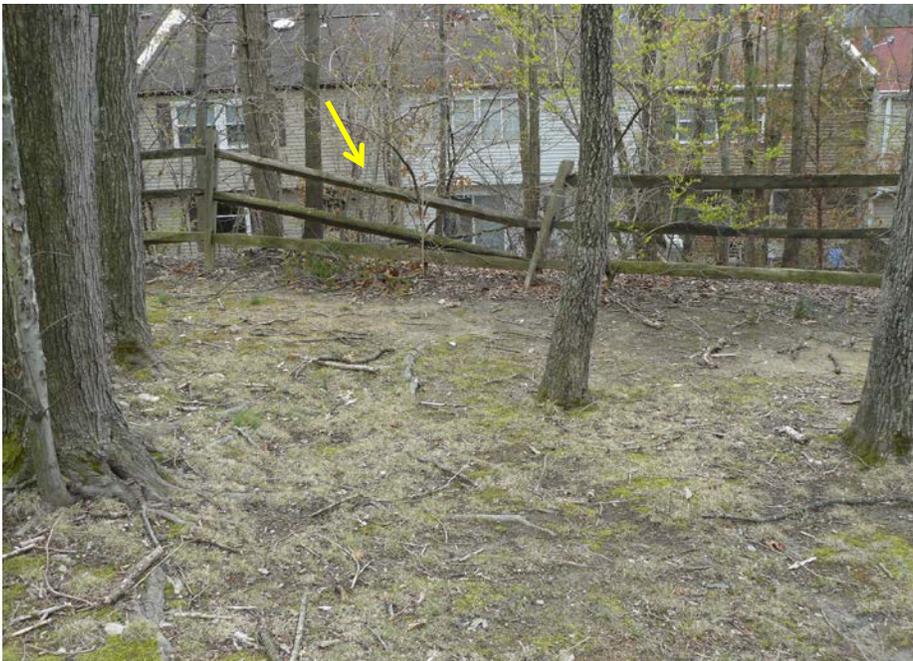
**PHOTO #13**  
The split-rail fencing ranges from poor to fair condition. This fencing should be re-installed along the new retaining wall.

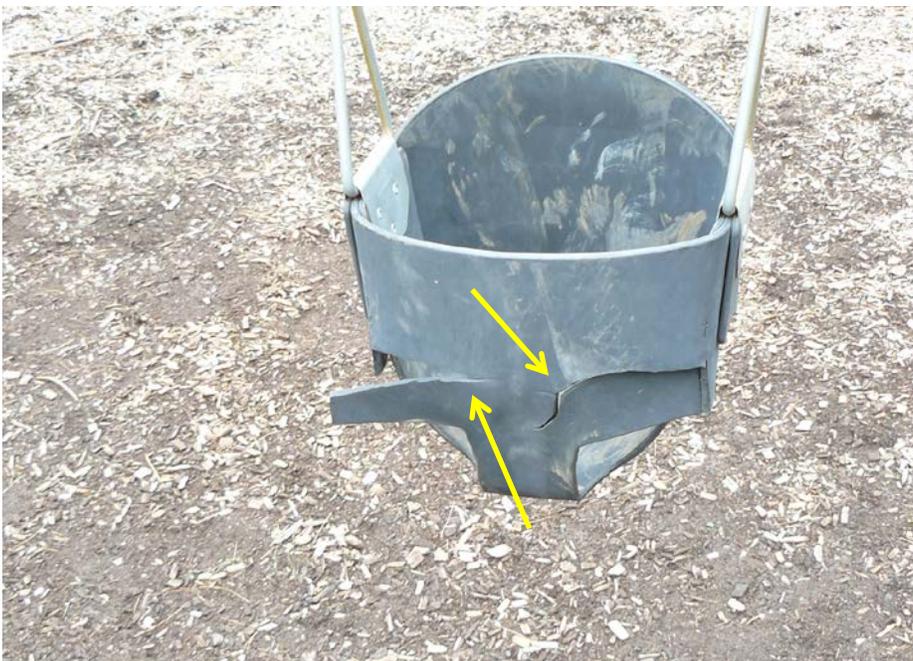
**PHOTO #14**  
This swing should be removed from use immediately.

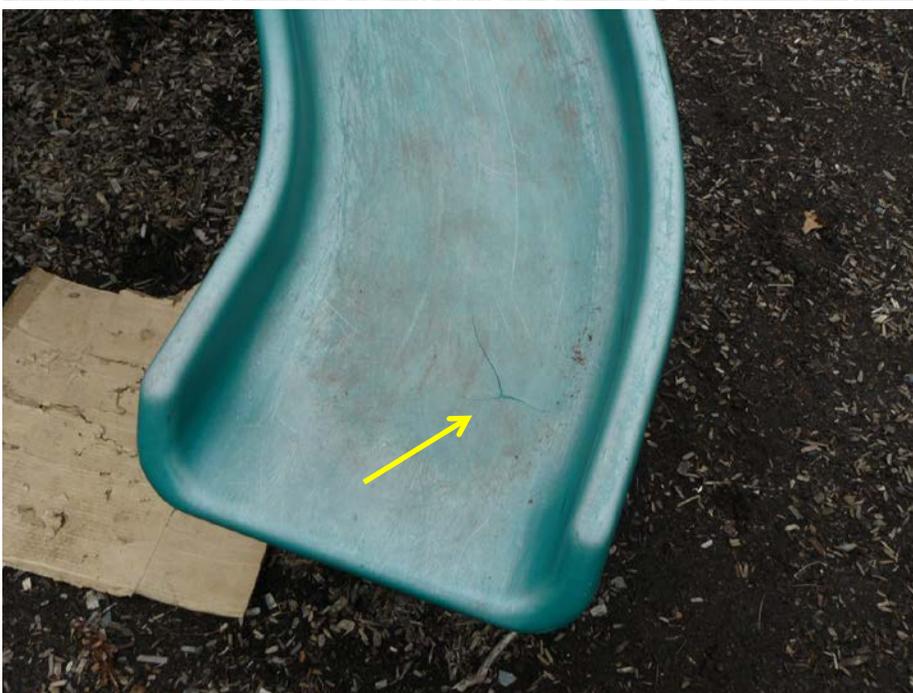
**PHOTO #15**  
Cracking was observed on one or two slides. This can cause a potential injury. The play equipment should be replaced near-term. All equipment should be evaluated annually to ensure safety.

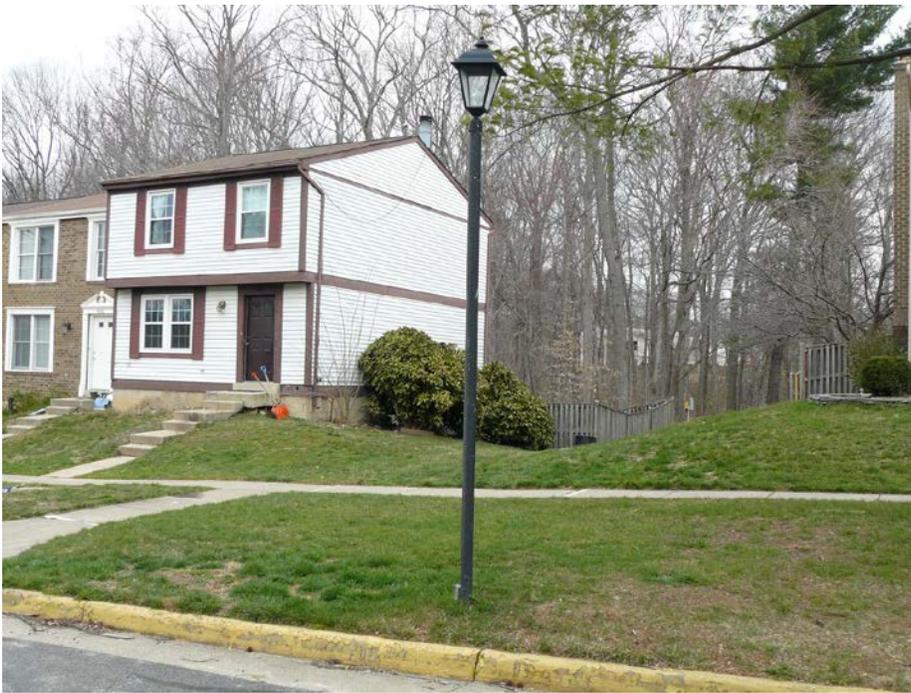
**PHOTO #16**

The three street lights and poles along Golden Leaf Court are in fair to continuing good condition. Lighting was not observed after dark.

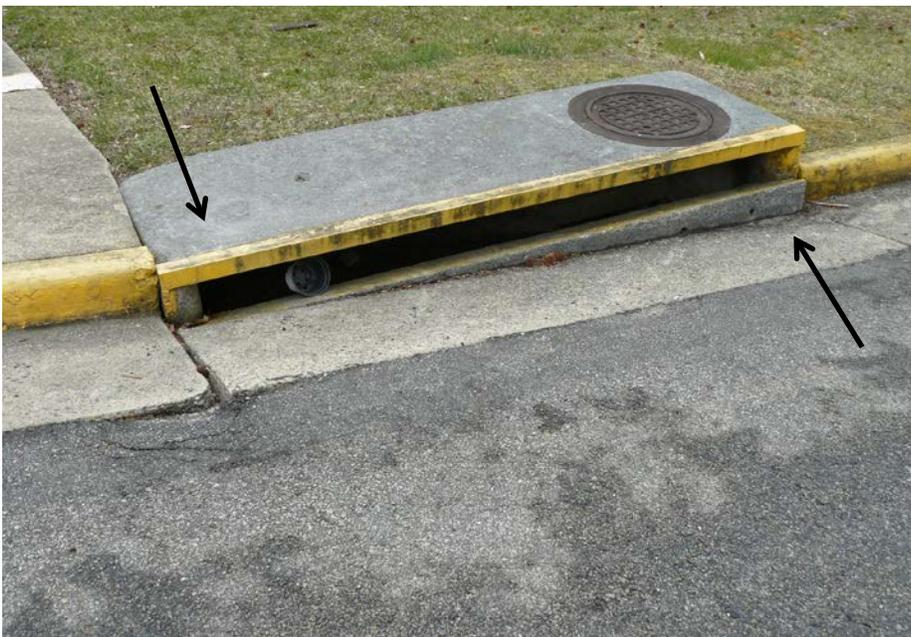
**PHOTO #17**

This storm water curb drop inlet along Golden Horseshoe Court has settled on one side and is only about 20% efficient. This inlet should be reset or replaced.

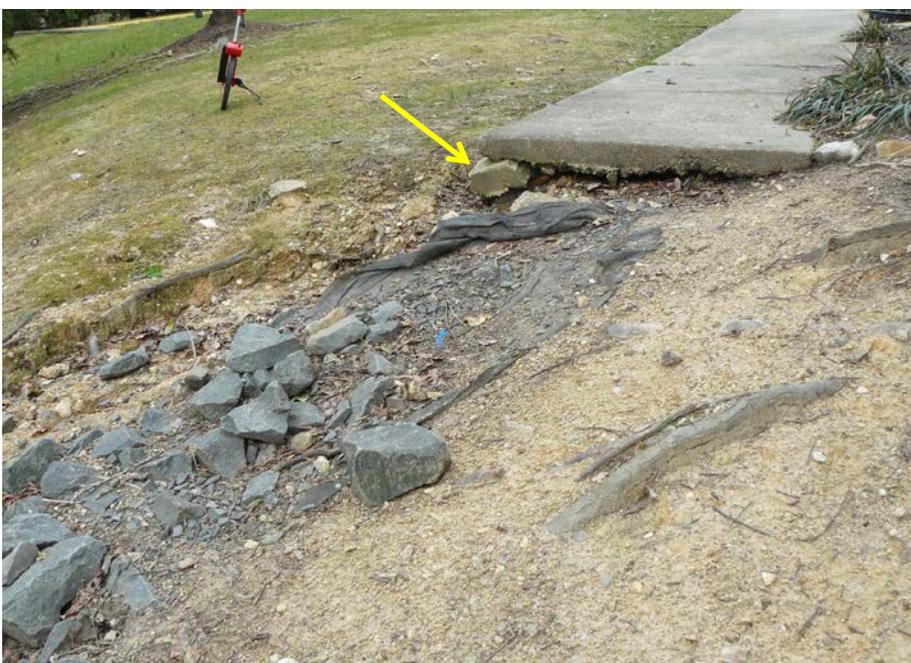
**PHOTO #18**

An erosion control project was completed at this location (at the end of Gutman Court) a few years ago. However, it requires additional work, as the end sidewalk panel is heavily undermined, and is being supported by a rock.
